6 National Dam Inspection Program.
White Oak Pond Dam (NDI Number
PA-00147, DER Number 64-12),
Delaware River Basin, Wayne
County, Pennsylvania. Phase I
Inspection Report. ~~REDACTED~~

PHASE I REPORT
NATIONAL DAM INSPECTION PROGRAM

Name of Dam: WHITE OAK POND, NDI NO. PA-00147
State & State No.: PENNSYLVANIA, 64-12
County: WAYNE
Stream: TRIBUTARY OF WEST BRANCH LACKAWAXEN RIVER
Date of Inspection: October 24, 1979

DATE: January 25, 1980

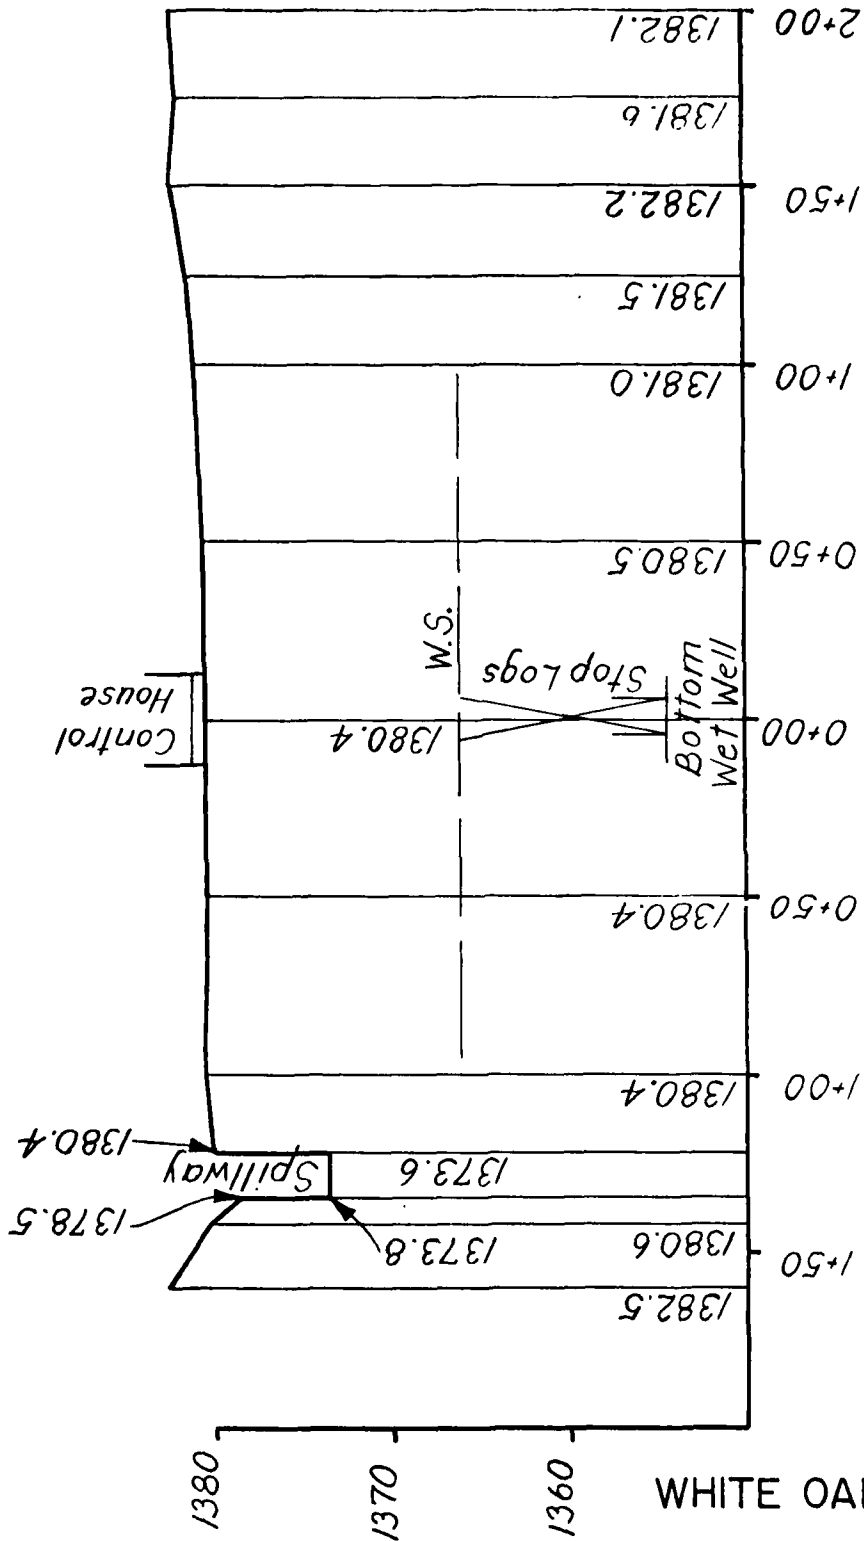
PLATE A-II

The breast of the dam is curved and is covered with a well maintained grass mat. The profile indicates a fairly level surface (Plate A-II). A wooden framed shed is located on the embankment over the wetwell. The downstream slope has a slightly battered wall formed with loose handlaid stone. This wall projects about nine feet downstream over the outlet structure. Although most of its surface was smooth and in one plane, a small area at the bottom of the wall bulges on both sides of the outlet structure. These "bulges" appear to be part of the original construction. It appears that the wall was built slightly wider at these locations, due to its height.
